WESTPORT'S PUMP STATION NO. 2 FORCE MAIN REPLACEMENT PROJECT USING HDD: A CASE STUDY

By: Bryan Thompson, Town of Westport, CT Abhinav Huli, Haley & Aldrich, Inc. Lori Carriero, Tighe & Bond

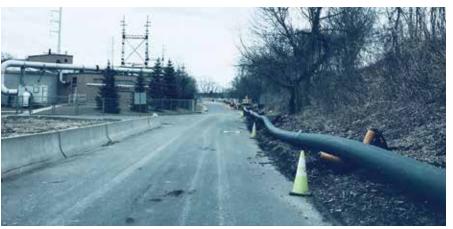
Figure 12: HDPE product pipe fused laid for pullback along Elaine road. WWPCF and I-95 are to the left and right side of the photograph respectively

The final HDD alignment was designed with HDD entry/exit angles of 18 degrees and 12 degrees on west and east sides with a total length of 1,300 feet and approximately 90 feet in depth from the HDD entry location. The pipe laydown for pullback was designed east of the river along the treatment plant access road. A combination of a steep entry angle and use of a steel conductor sleeve was recommended to be used on the HDD entry (west) side to mitigate the potential for inadvertent returns while drilling from the ground surface to the top of bedrock. This was also intended to mitigate the potential for over-excavation and settlement of the nearby utilities and

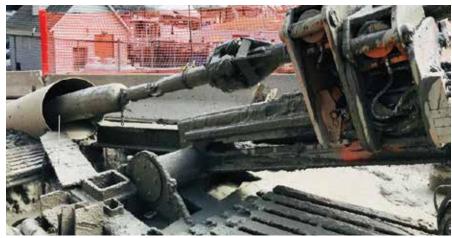
Figure 14: Product pipe pullback complete

A final swab was completed using a 22-inch diameter reamer. The 14-inch diameter HDPE product pipe was then pulled in place over a two- day period. Considering that the drill was completed almost entirely in rock, Carson pulled approx. 500 feet of pipe on day one and left the pipe in the borehole overnight. The remainder of the pipe was pulled on day two without any issues. A hydrostatic pressure test was successfully performed upon completion of the pipe pullback.
