Governors Island Park and Public Space

New York's Most Unconventional and Resilient Hills

David G. Winter, P.E., LEED AP, M.ASCE¹ and Brice Exley, P.E., M.ASCE²

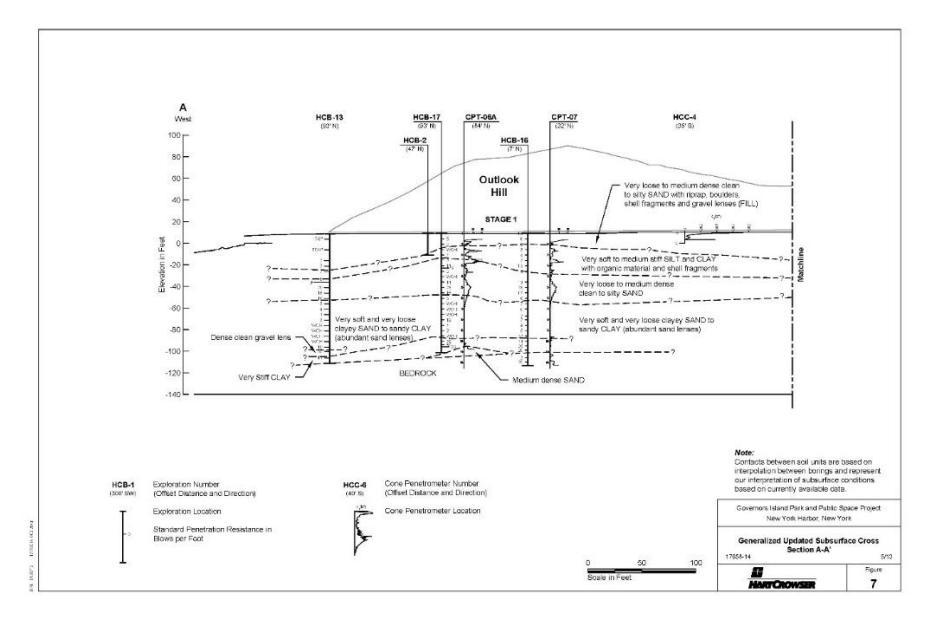
FIGURE 3. GENERALIZED SUBSURFACE CROSS-SECTION

2010 and 2013 HCHA progressively identified and filled data gaps to create a comprehensive understanding of the nature and variability of the soils across the site. HCHA explorations included 25 onshore borings, 16 onshore cone penetrometer probes, 6 groundwater monitoring wells, 4 infiltration tests, and many shallow test pits. In addition, the work included 3 offshore borings and 3 offshore cone penetrometer probes (CPT). There was a higher strength "crust" at and just below the ground surface. The explorations then showed a variable amount of recent fill – typically about 20 to 35 feet – above an upper soft clay. The clay was 5 to 30 feet thick and was above a loose to medium dense sand that varied from 20 to 30 feet thick. Below that was a second even softer clay unit as thick as 55 feet (Figure 3). Standard Penetration Test (SPT) blow counts were often 0 in the material, and normalized cone tip resistances, Qt, were about 3 to 5. The lower clay had interbedded thin sand layers. At a depth of about 125 feet near the shoreline and 110 feet farther inland, the soft clay gave way to very dense glacial till and hard clay, and bedrock. Groundwater was at about elevation 4 feet and was not significantly influenced by harbor tide changes.

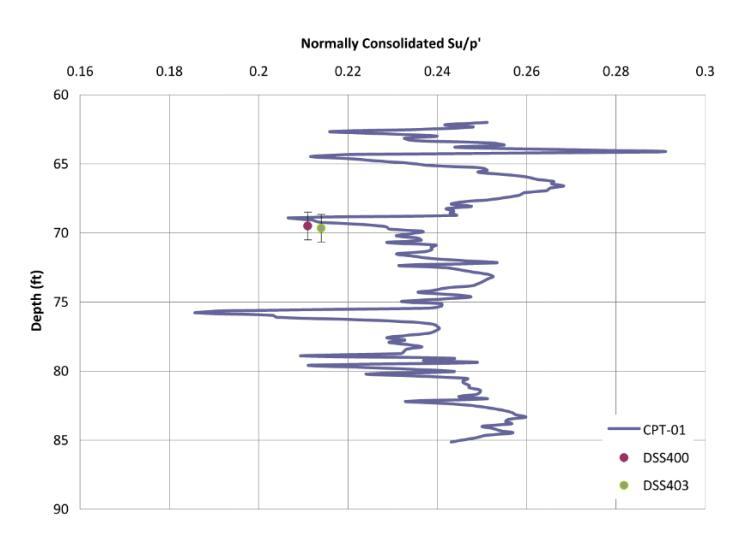
FIGURE 4. COMPARISON OF CPT AND DIRECT SIMPLE SHEAR STRENGTH TEST RESULTS

The friction angle was estimated by a combination of STP correlations (Hatanka and Uchida 1966, Schmertmann 1975) and CPT correlation (Kulhawy and Mayne 1990). The initial undrained shear strengths were estimated by considering CPT correlations using N_{kt}=15, plasticity index, typical published SHANSEP parameters (Ladd 1991), as well as CU and UU triaxial tests. Preconsolidation pressures were determined from consolidation tests on Shelby tube samples. The resulting initial undrained shear strengths were plotted together in an effort to cross-check each method. A trend of shear strength closely fitting a shear ratio of 0.22 as recommended by Ladd was observed. These values were later refined using the effective stress derived friction angle of the fine-grained soils using the CPTu and critical state soil mechanics under the direct simple shear stress path as well as direct simple shear tests, which is reflected in Table 1. An example of the comparison between the CPT derived and direct simple shear test normally consolidated undrained shear strength ratios are provided in Figure 4.

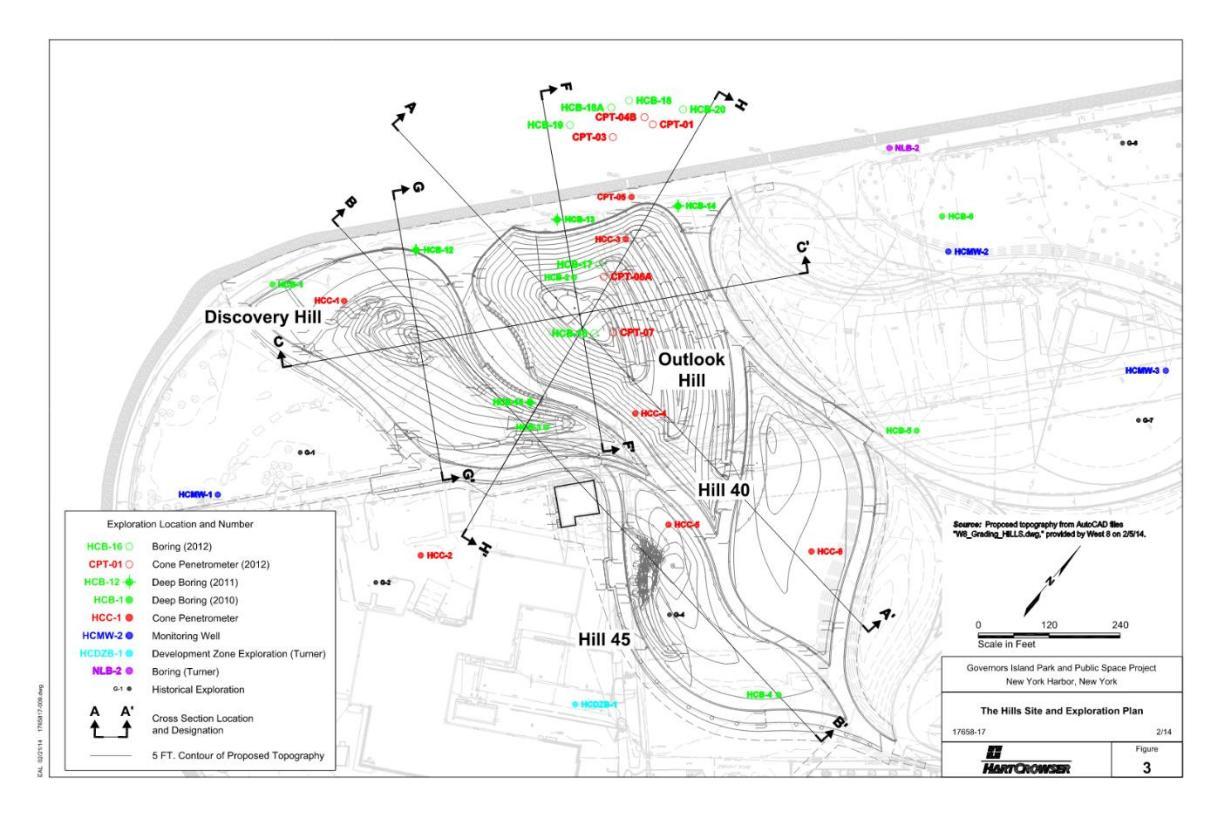
FIGURE 5. HILLS LAYOUT AND SUBSURFACE EXPLORATION CROSS-SECTION LOCATIONS

The four hills were called Grassy (40 feet above sea level), Slide (45 feet above), Discovery (57 feet above), and Outlook (90 feet above). Outlook has the steepest (1.25H:1V) and tallest slopes facing and right next to the seawall. Figure 5 shows the layout of the hills, and some of the explorations completed and sections developed to identify the subsurface conditions.

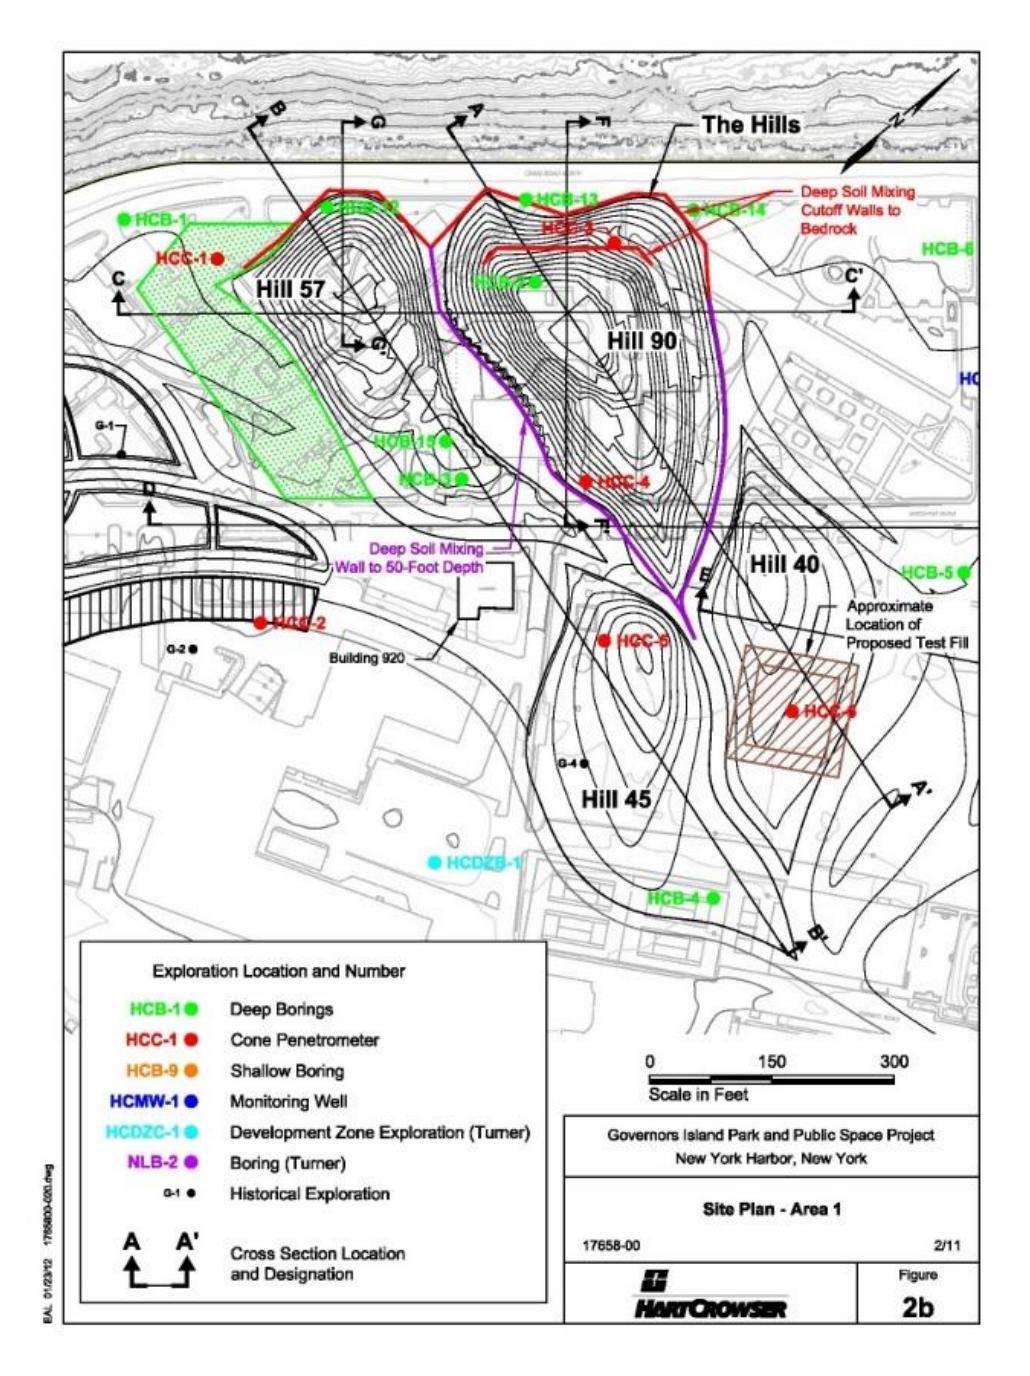
FIGURE 6. SCHEMATIC DESIGN SOLUTION WITH CUTOFF WALLS

The schematic design solution to the steep slopes and heavy hills adjacent to the shoreline included a pair of below-grade 8-foot-wide deep soil mixing (DSM) cutoff walls (Figure 6), staged construction that required a full year of consolidation time, and Geofoam blocks to reduce the weight. While this combination of solutions met the factor of safety requirements for global stability, West 8 and the Trust were clearly not enamored with it, and it was significantly more expensive than the budget allowed.

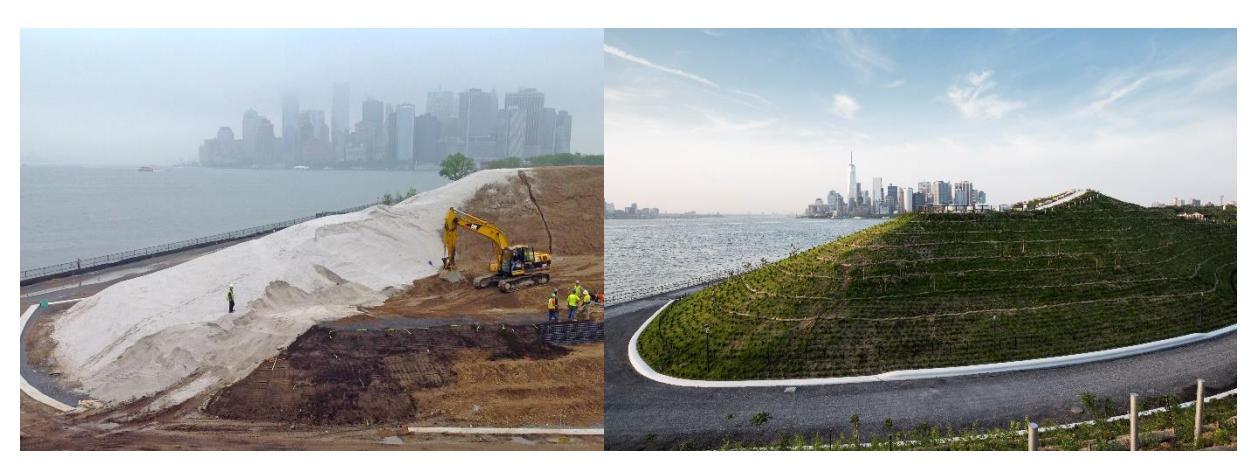
FIGURE 7. LIGHTWEIGHT FILL INSTALLATION AND OUTLOOK HILL COMPLETED

Lightweight fill. Traditional fill and construction assumptions would make Outlook and Discovery Hills very heavy, with concentrated loads from steep slopes located less than 50 feet from the seawall/shoreline. Even if the rate of construction were limited to allow pore pressure dissipation and strength gain, stability was a problem. In addition, settlement and lateral movement around the hills and along the seawall were still significant, even with the 10 feet lower hills redesigned by West 8. The Geofoam blocks idea (with enough soil cover to keep the hills in place during the design storm and earthquake evens) was seriously considered. Although Geofoam had a good record of performance in subgrade applications, there was less confidence in their long-term performance as building blocks for elevated surfaces. And a more limited use of Geofoam within the middle of the hills did not provide enough weight relief to justify the comparatively high cost. HCHA talked with local suppliers about lightweight granular materials, included naturally occurring waste products and manufactured products. With several similar products easily available for barge transport to the island, the lightweight aggregate was selected. Final design included about 70,000 cubic yards of high-strength lightweight fill (Figure 7) used in a modeled and prescribed zone of the hill (the lighter shade material in the photograph below) to reduce deformations at the shoreline and seawall and increase the global factor of safety.

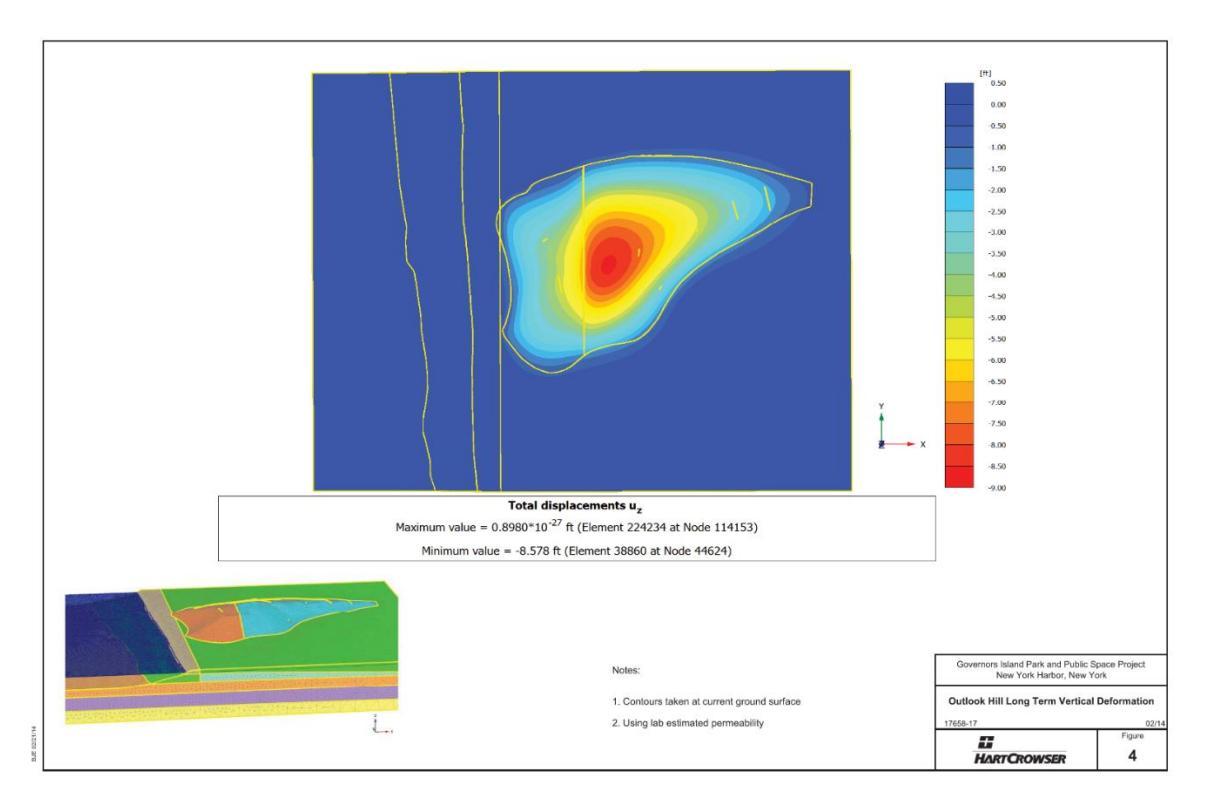
FIGURE 8. MODELED SETTLEMENT DURING CONSTRUCTION

Ground settlement. HCHA estimated settlement response using Settle3D and PLAXIS 3D as well as traditional onedimensional consolidation theory. At full construction and 95% consolidation the hills were predicted to settle between about 3.5 feet (Slide and Grassy) to 6 feet (Discovery) to 8.5 feet (Outlook), which is shown on Figures 8 and 9. This settlement would occur over about four years. The settlement was generally linked to height of the hill, but also varied by type of material and steepness of the slopes, and other geometry. Even though the expected settlements were significant they were not abrupt, and flexible utility connections could be designed to withstand the movements.

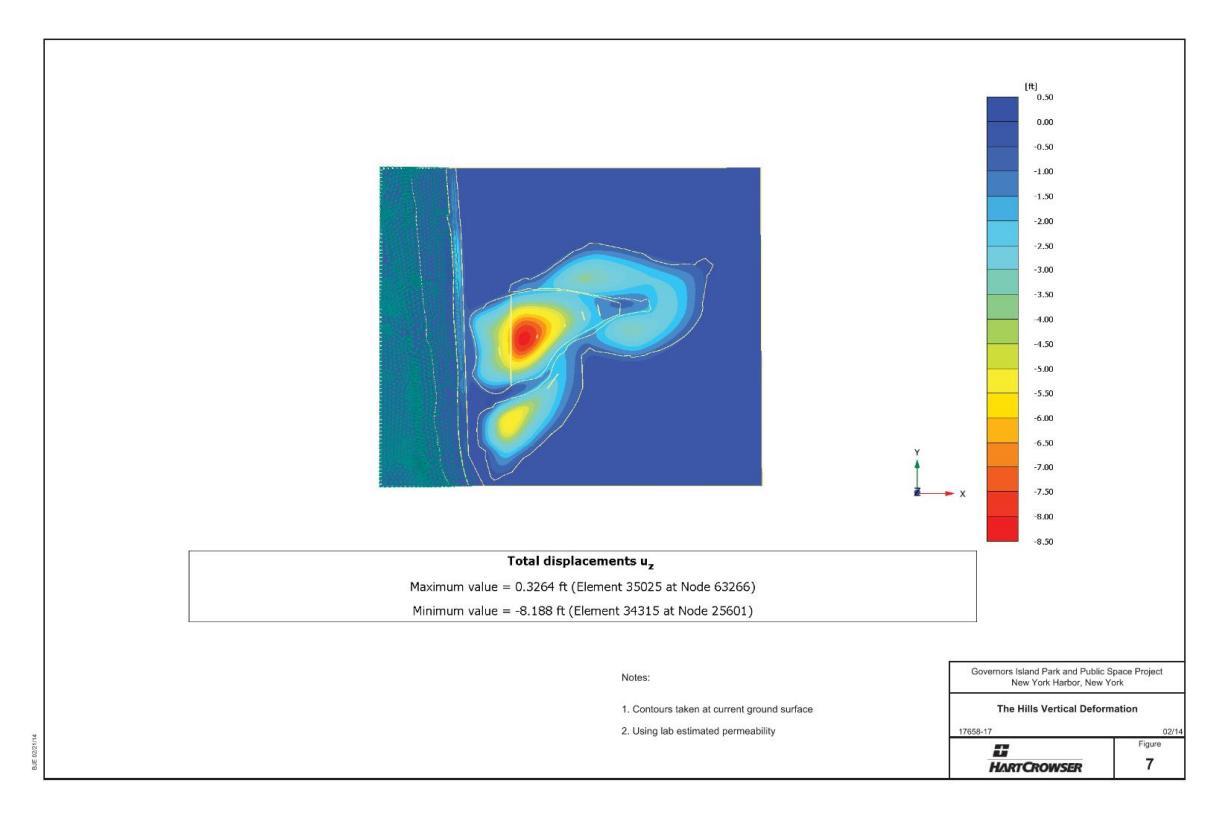
FIGURE 9. MODELED SETTLEMENT AT 95% CONSOLIDATION

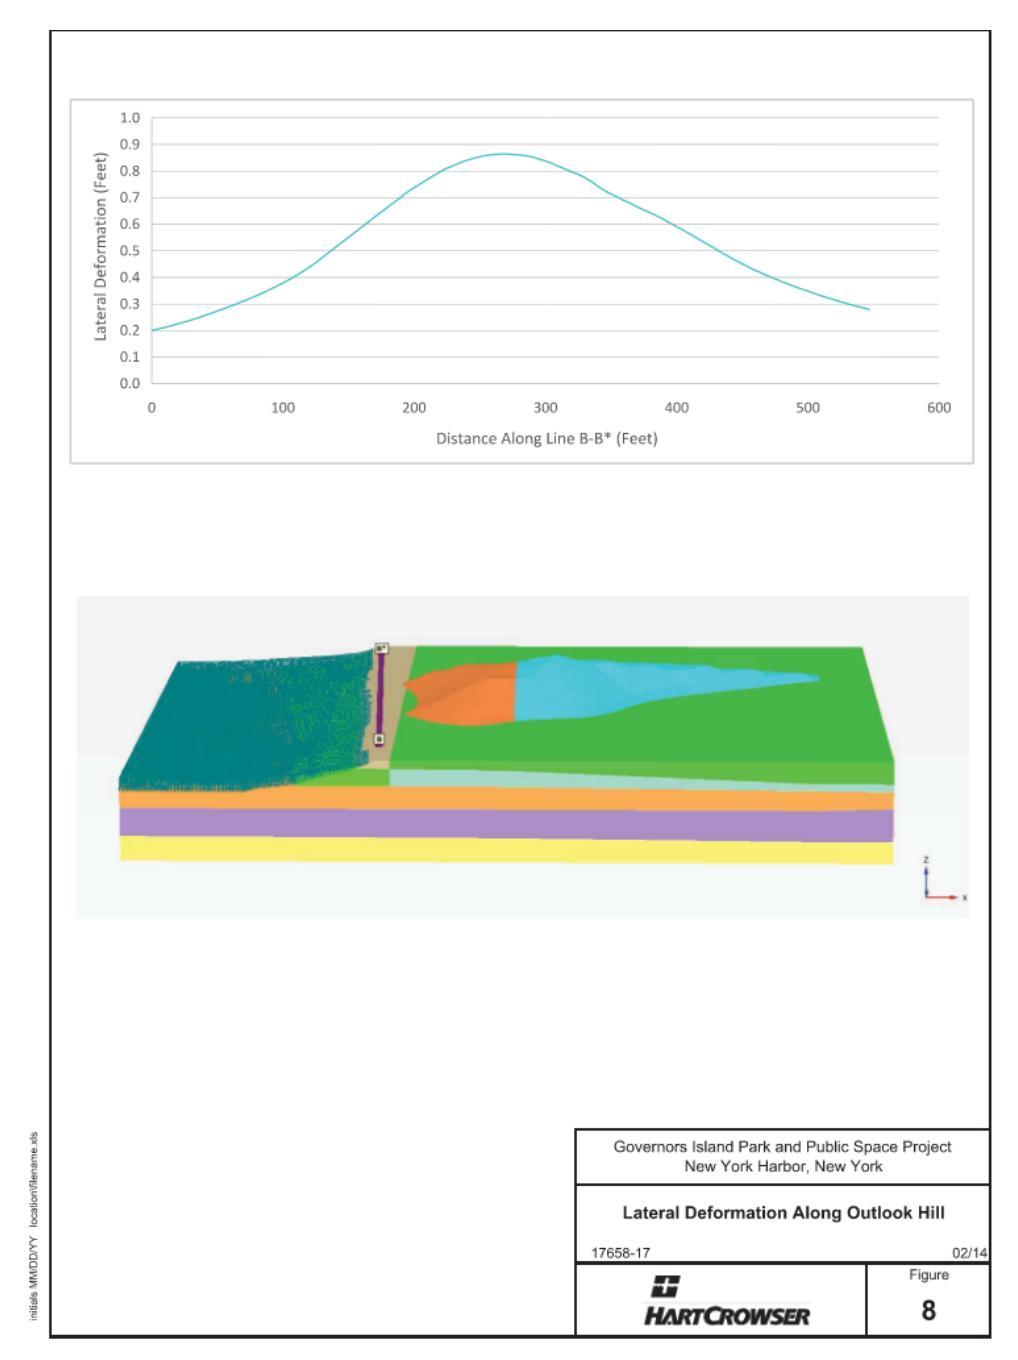
FIGURE 11. ESTIMATED EXTENT OF LATERAL DEFORMATION AT OUTLOOK HILL AND SEAWALL

The movement of the subsoil around and below the hills could have caused movement of the seawall. As shown in Figure 11, HCHA predicted 8 to 12 inches of lateral deflection and about the same amount of settlement. The revetments and a concrete topping block wall were designed to be easily adjusted if settlement was excessive.

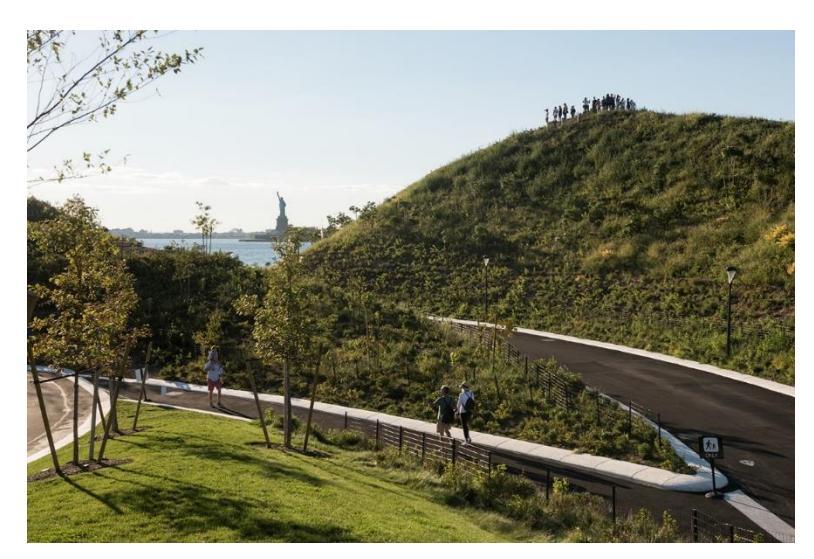
FIGURE 12. PATHWAY EDGES FUNNEL WATER TO INFILTRATION LOCATIONS

Another of West 8's resilience design components required HCHA to prepare specific and targeted estimates of ground settlement at the base of the hills. Walkways around, between, and through the park and hills were lined with graceful molded precast concrete edges. These blocks had designs that flowed, and gaps between the blocks were both undesirable and unsightly. The HCHA Settle3D model calculated precise estimates of total and differential movements along the pathways, allowing the precast edges to be set with confidence. More importantly, the pathways and the edges were designed to temper wave action and funnel overflowing water from the harbor and channel it to infiltration locations around the hills and park (Figure 12).
